## OBSERVATION OF PARTIAL INTERNAL FLASHOVERS ON VACUUM INTERRUPTER TEST SPECIMEN WITHOUT METAL VAPOR SHIELD

The present contribution is an examination of a modified VI devoid of a metal vapor shield with the objective of observing the influence of the shielding on the breakdown process under lightning impulse stress. The results of the performed measurements are documented in the form of voltage data and recordings with a high-speed camera.

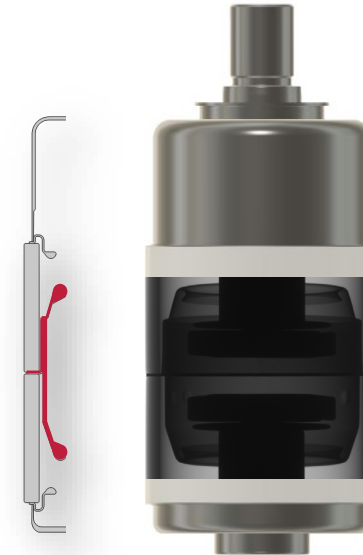
REF

- VI ABB VG6 in ambient air
- Two DUT with different metal vapor shield configurations
  - Full shield (REF)
  - Without metal vapor condensation shield (OMS)

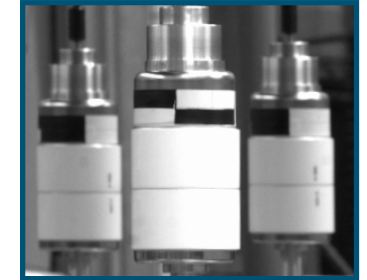
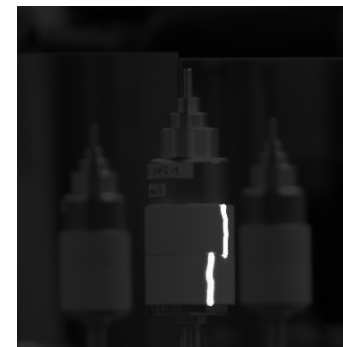
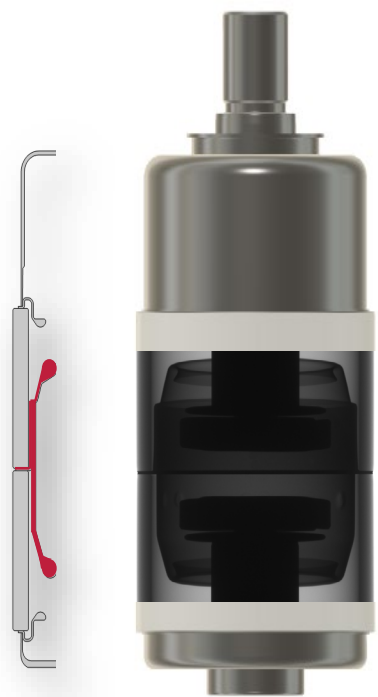
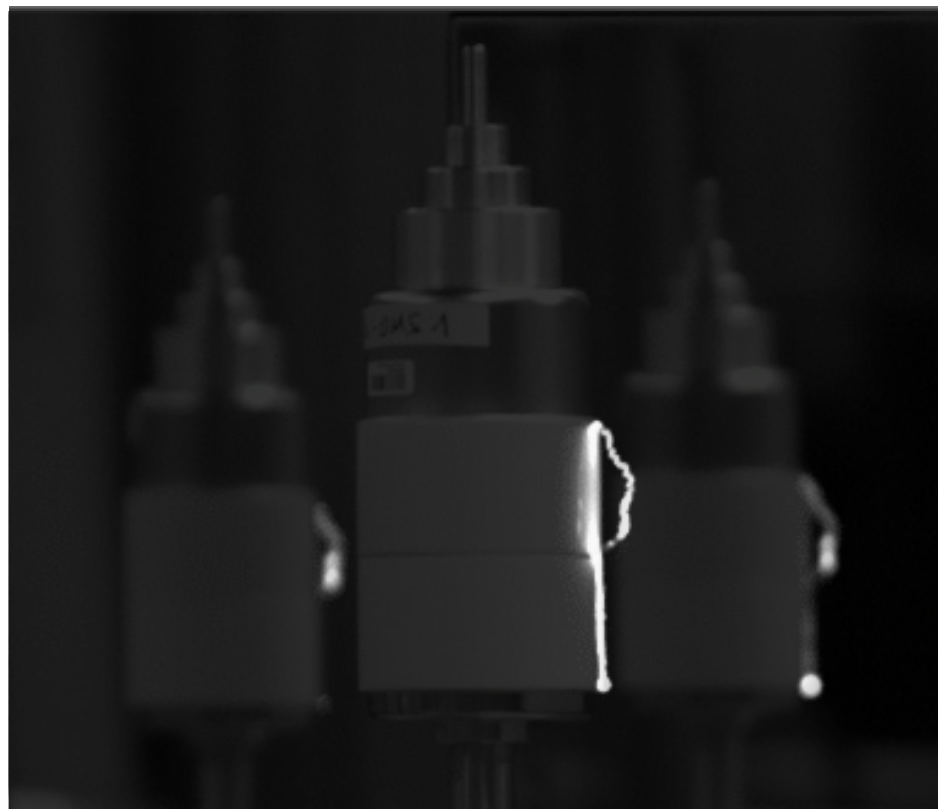
## Analyses of external flashover pattern with high speed camera footage

- Analyses of flashover pattern using speed camera recordings
    - 36.000 fps
    - Mirror setup for full view of external VI insulation
  - Example: typical discharge REF VI with negative polarity stress
  - Discharge path clearly visible
  - Split of flashover path with offset at brazed seam
  - Flashover follows ceramic surface
- Complete external surface flashover
